## **BIG CICERO CREEK WATERSHED FLOOD AND EROSION RISK MANAGEMENT PLAN**

### **BIG CICERO CREEK JOINT DRAINAGE BOARD**

#### **CHRISTOPHER B. BURKE ENGINEERING, LLC**

November 2014

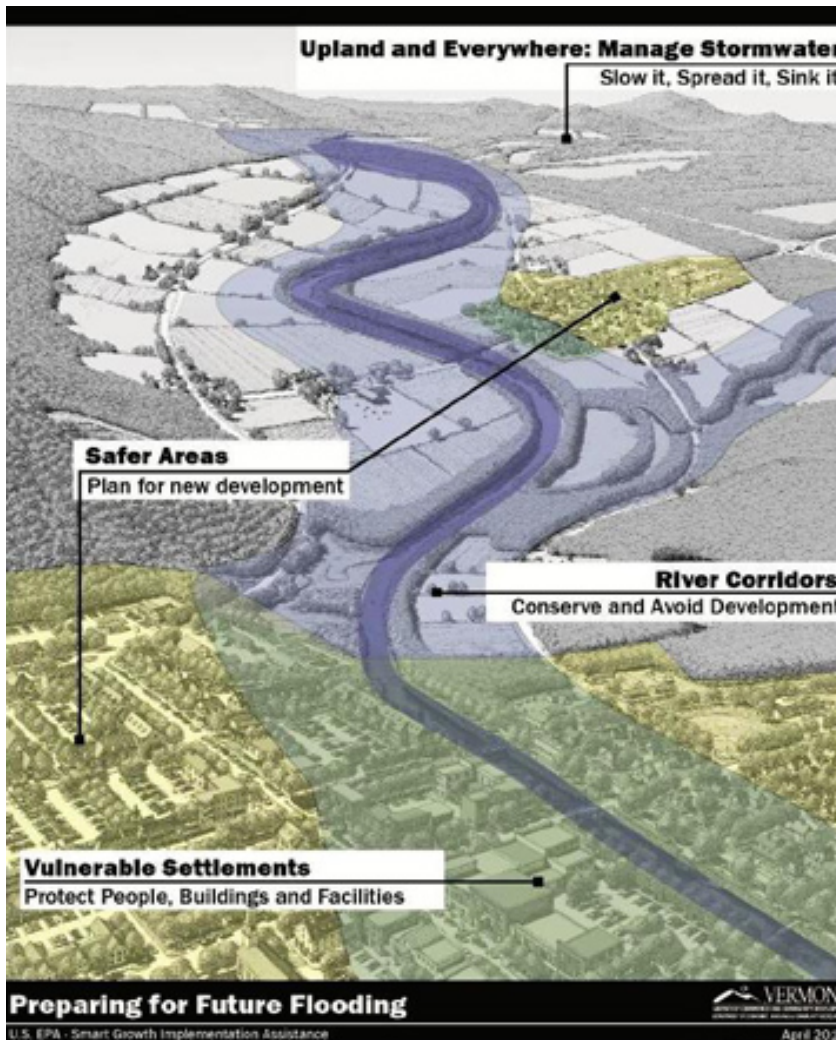
been investigating others. The image of a flood resilient watershed (left) shows how multiple approaches to managing flooding can work together.

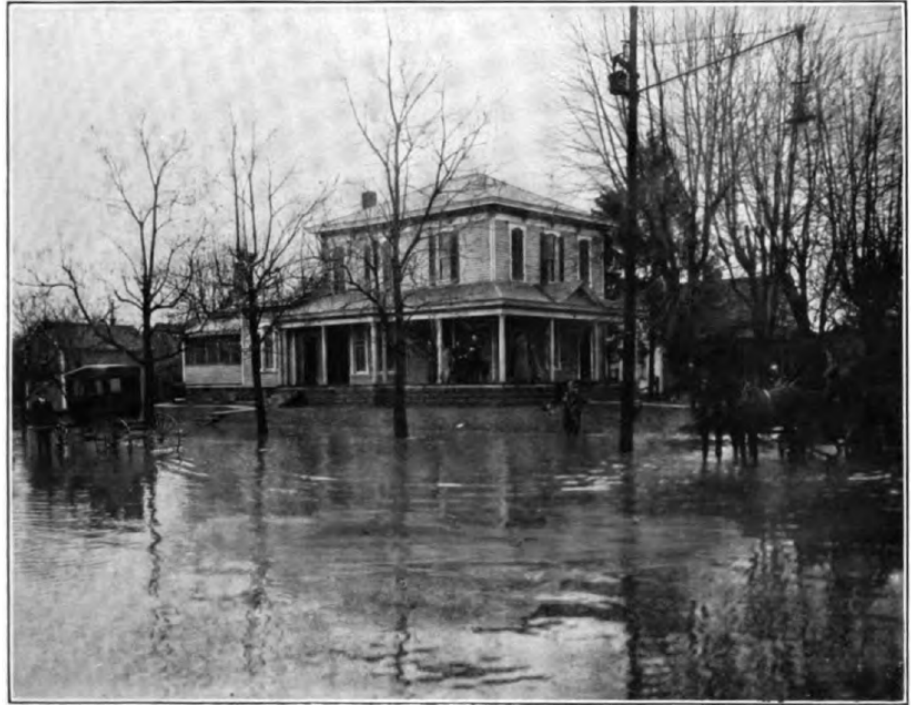
*Figure 1-1: 1913 Flood Photograph*

Flooding is a long standing problem in the Big Cicero Creek watershed as the following 1913 photograph of a house at the corner of Adam and Independence Streets in Tipton indicates (**Figure 1-1**). Notice the man and horses standing near the house in the right hand portion of the photo. Based on this photograph, and images taken during the April 2013 flood, the 1913 flood appears to be the flood of record in the Tipton area.

**HIGH WATER, 1913—ADAMS AND INDEPENDENCE STREETS, TIPTON.**

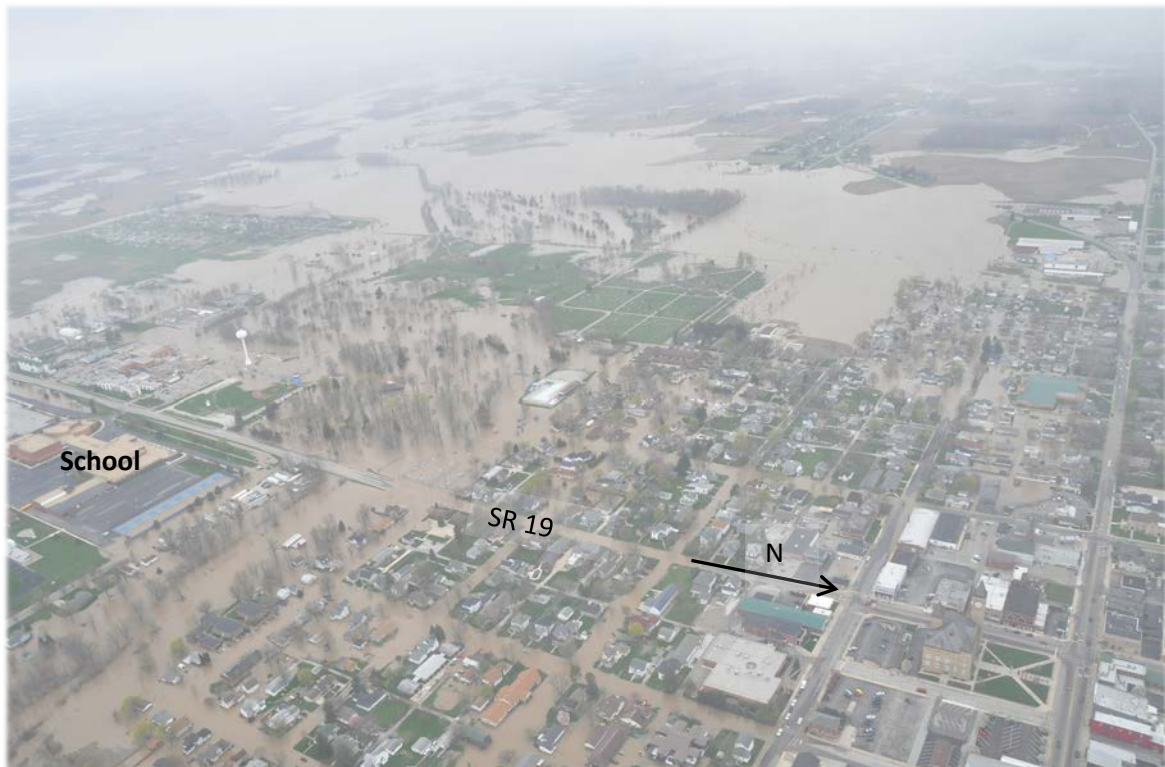
**Figure 1-4: Aerial View of Tipton during April 2013 Flood**

Tipton reported \$2.5 Million in damages, primarily in the low lying residential areas in the south west corner of the city between 1<sup>st</sup> and 4<sup>th</sup> Streets. Seeking

In April 2013 a major storm delivered an average of 4.5 inches of rainfall across the Big Cicero Creek watershed. Major flooding and some erosion along Big Cicero Creek in Tipton and surrounding agricultural areas resulted. An aerial view of the flooding is shown in **Figure 1-4**.

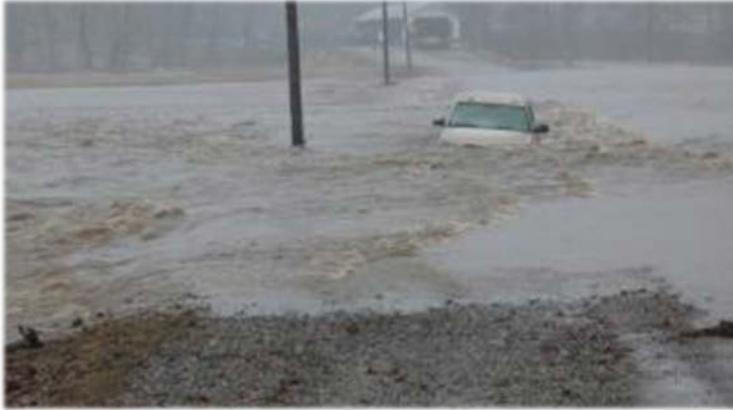
**Figure 2-7:** A truck is submerged after attempting to drive through a flooded road in Montgomery, Vt.

In the Big Cicero Creek corridor, many bridge structures are significantly higher than the road approaches so people don’t realize how deep the flooding is on the road leading to the bridge. Such was the case for the truck shown in **Figure 2-7**. The covered bridge behind him is shown above flood waters but the road was well below flood level.

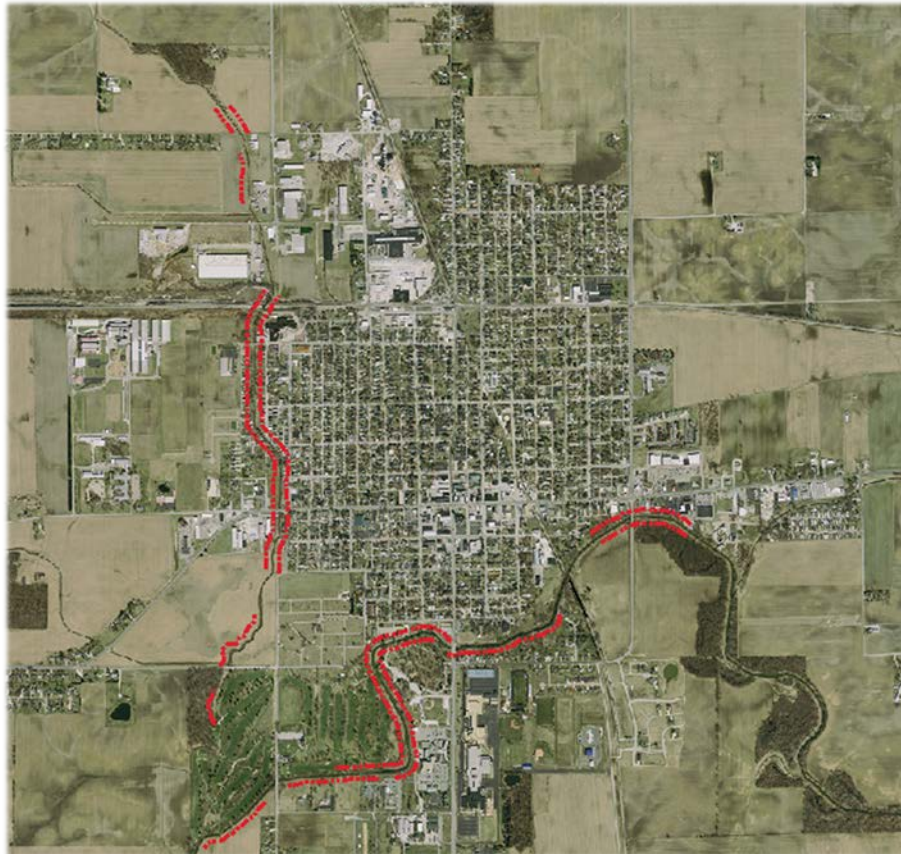
A stream stability assessment identified significant erosion in three watersheds. The affected reaches along Big Cicero Creek and Buck Creek are shown in **Figure 2-14**. The section along Bacon Prairie Ditch is not shown as it is confined to one area where farm animals have access to the stream.

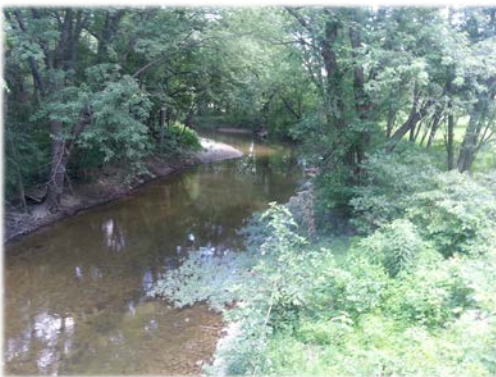
**Figure 3-5: Big Cicero Creek near Mt Pleasant Road**

The predicted 10-20% increase in median runoff from 2041-2060, coming on top of a 37% increase in very heavy precipitation (= heaviest 1% of all daily events) from 1958 - 2012, indicates that the trend of increased runoff and decreased infiltration is likely to continue. Fortunately, evidence suggests that stable stream channels like the one shown in **Figure 3-5** that are connected to well-vegetated floodplains can sustain flood flows without impairment. Erosion is most pronounced in disturbed stream reaches – as seen in the increased erosion in and around Tipton. The

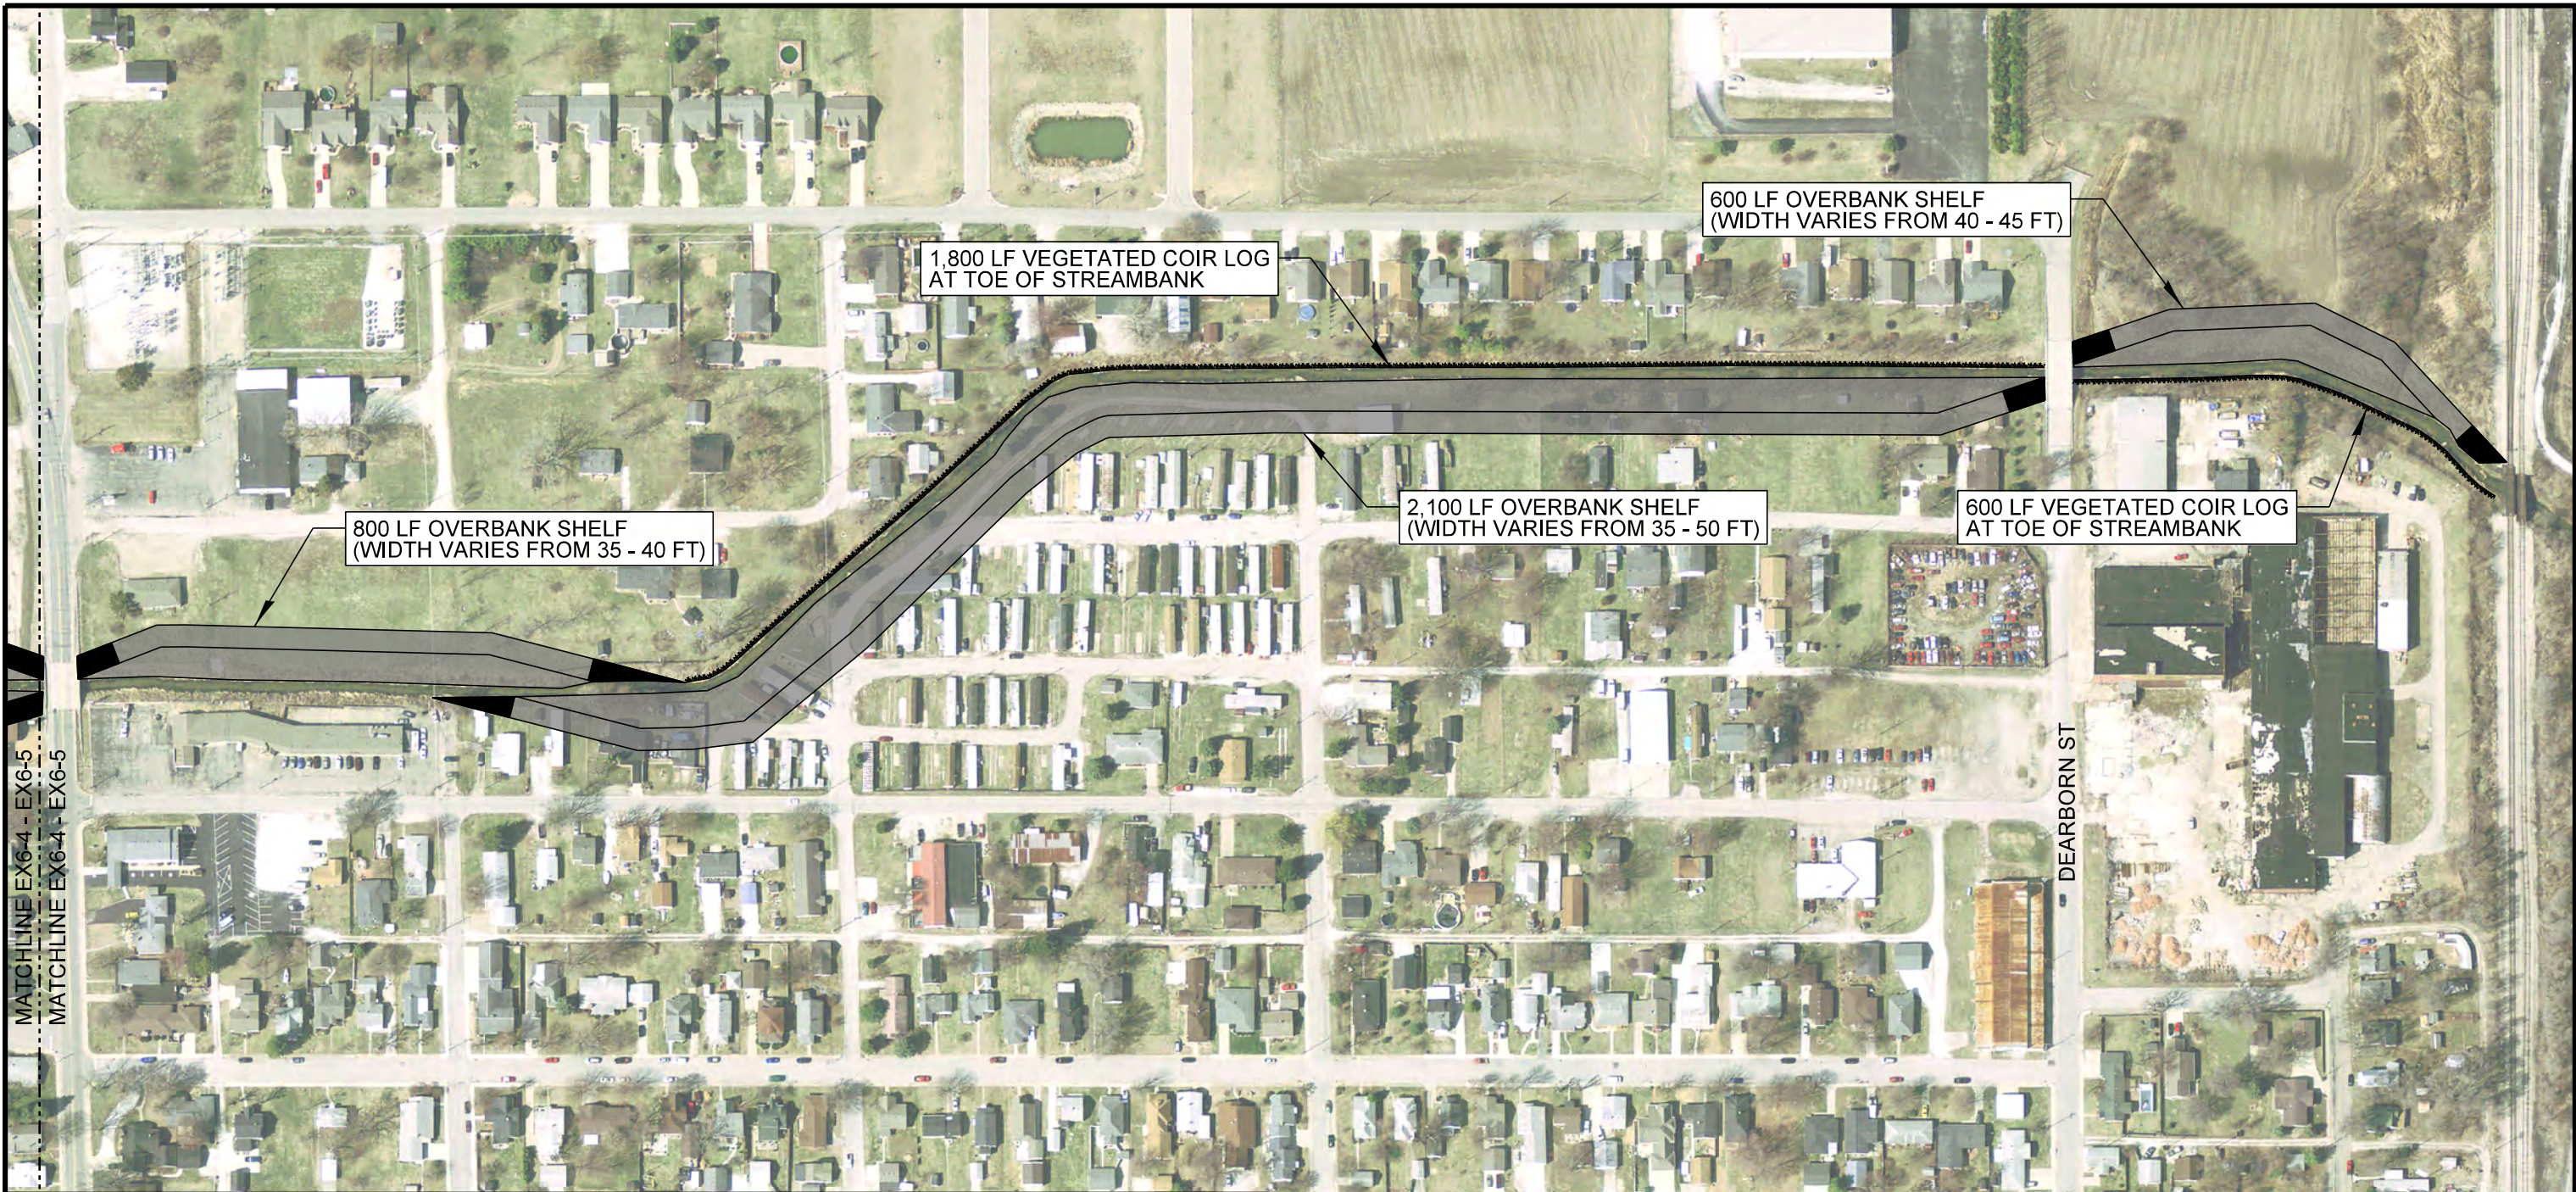
**EX6-4**

1 OVERBANK SHELF TYPICAL SECTION  
NOT TO SCALE

The recommended 2-stage ditch, if constructed along Buck Creek and Big Cicero Creek in the Tipton area, will lower
